# San Fernando, California, Earthquake of February 9, 1971

U.S. DEPARTMENT OF COMMERCE  
National Oceanic and Atmospheric Administration

*Part B. Buildings continued; Soils and Foundations*

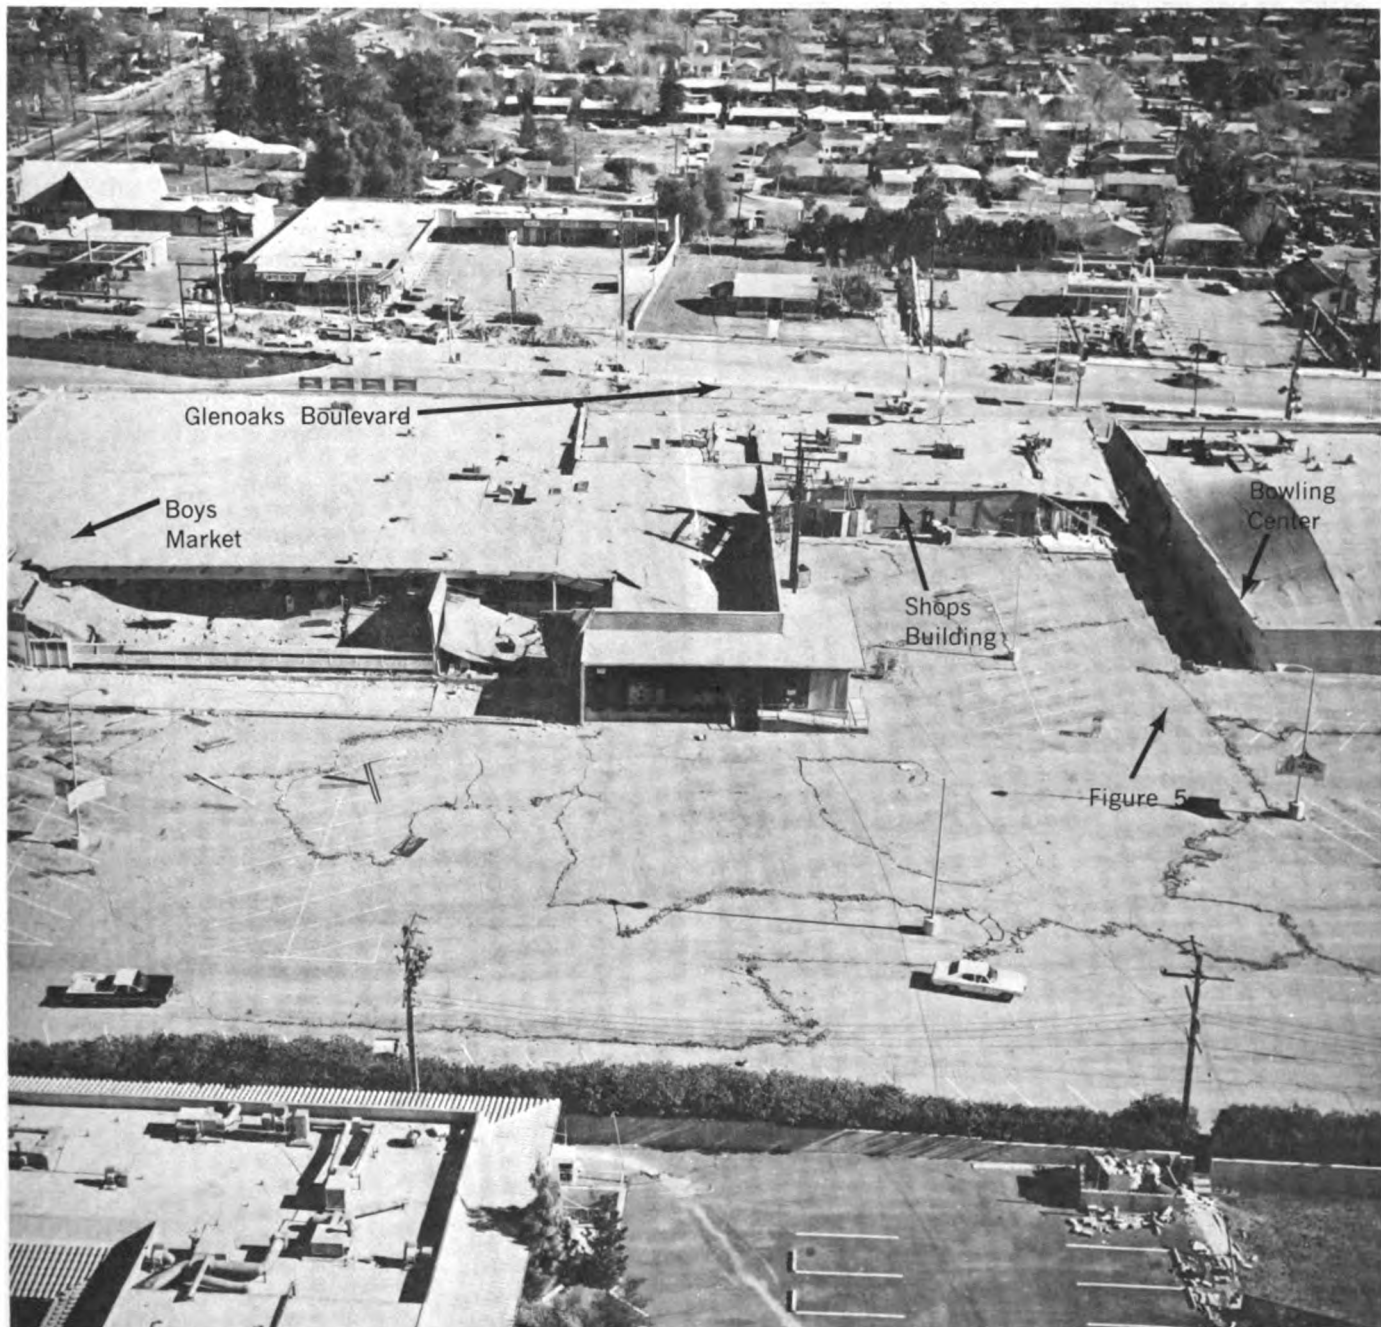
This building site is located on the Sylmar segment of the San Fernando fault zone. It is located on the extreme west end of the surface expressions of differential movements in this segment. Vertical and horizontal permanent differential movements, in addition to both compressive and tensile forces, were active in the area. Across the disturbance zone and within a few hundred yards of the building site, a compressional shortening of 0.3 m and a differ-

Figure 4.—Boys Market site. Looking north, showing in addition to the market, the adjacent shops building and bowling center.  
Robert E. Wallace, USGS, photograph.

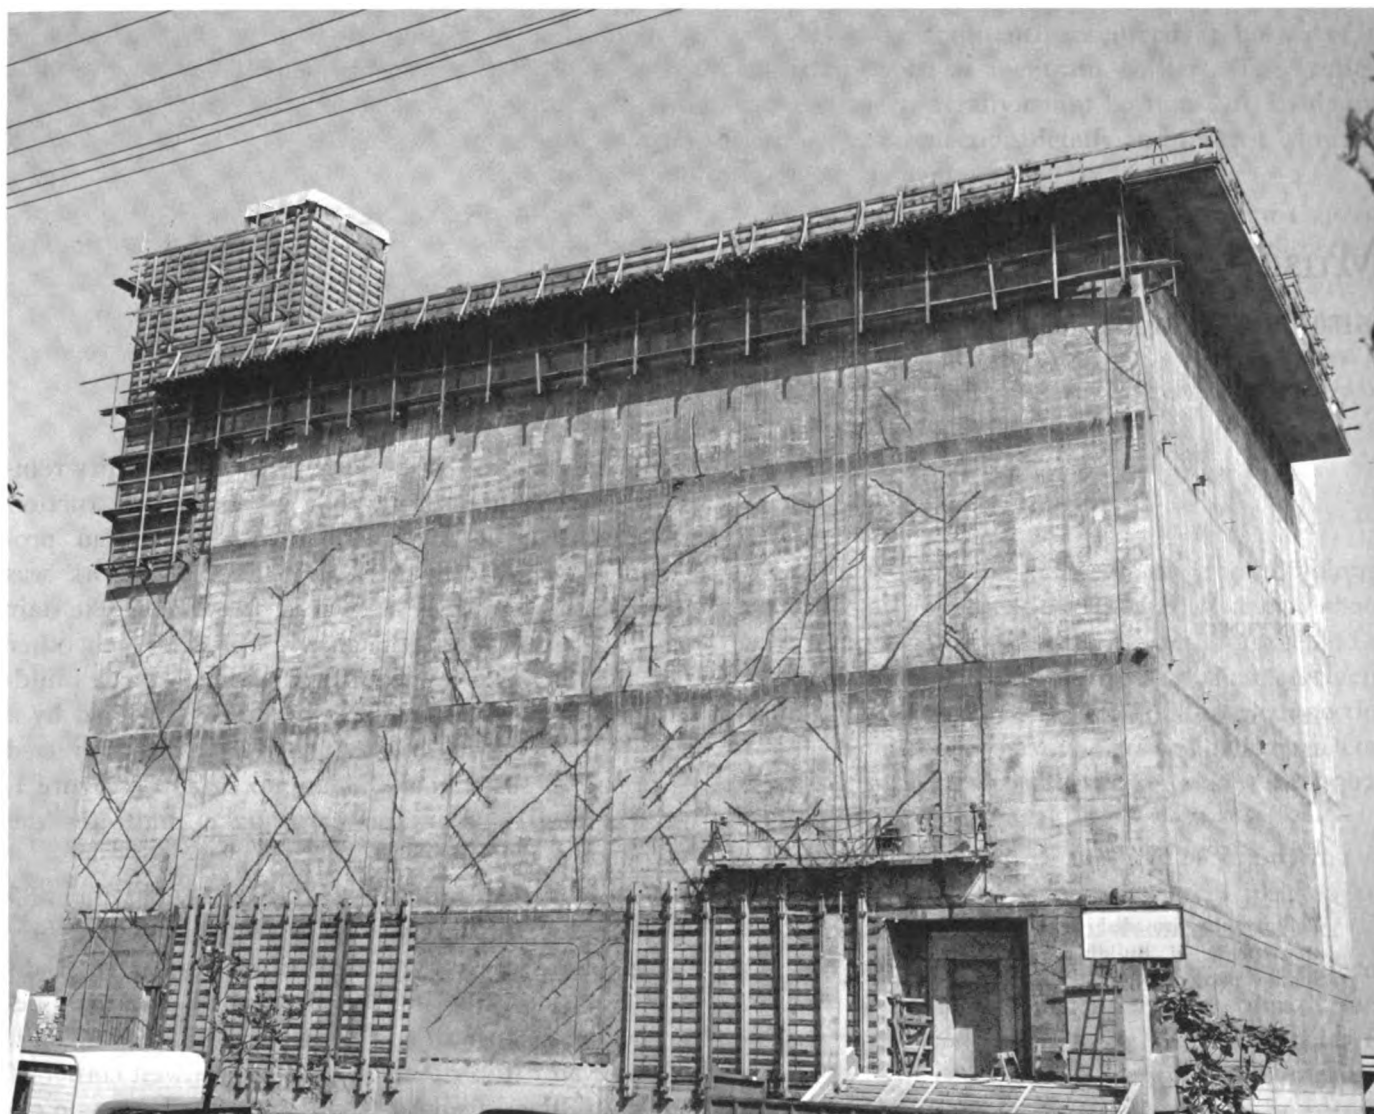
*Figure 1.—Museum for Antique Cars. Building north wall, with repair of wall cracks in progress.*

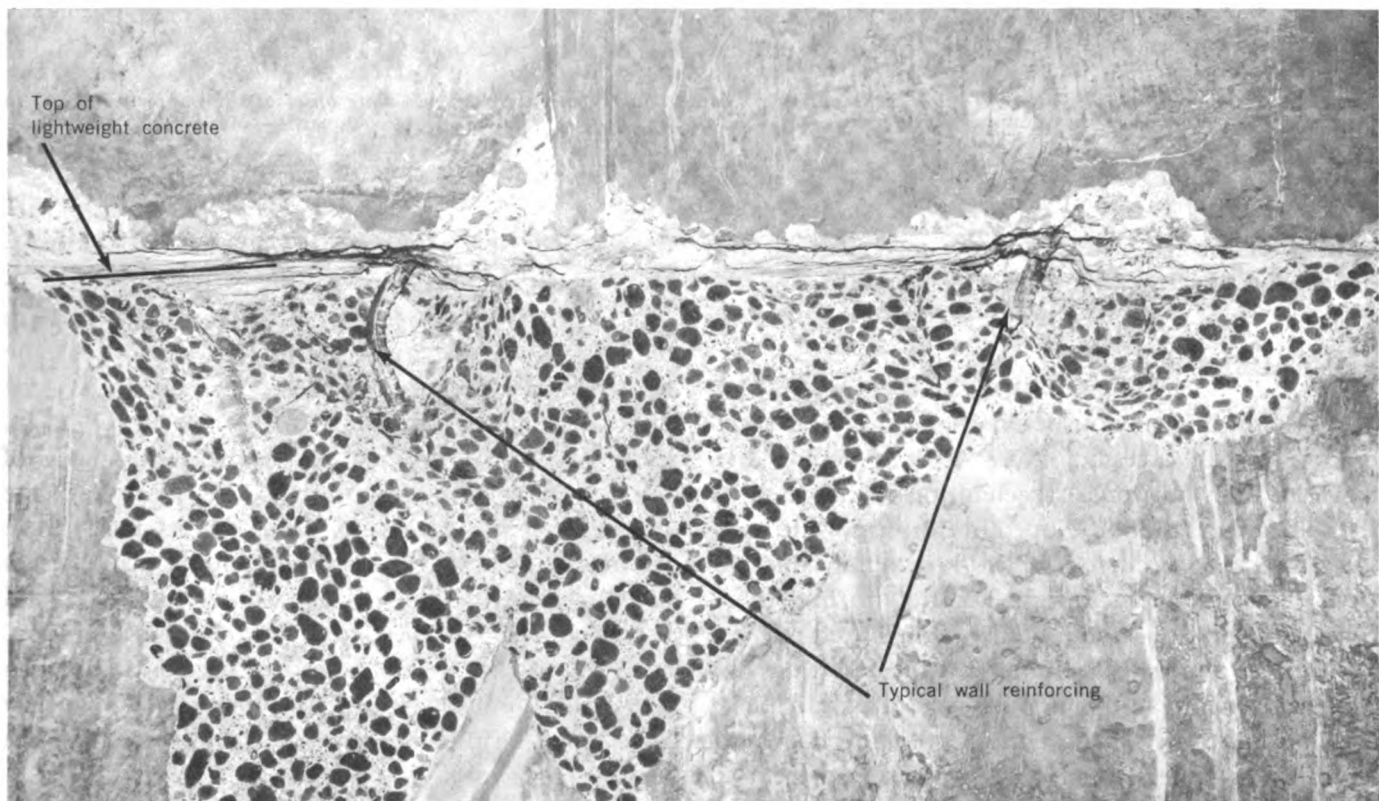
Figure 8.—Museum for Antique Cars. Fracture joint at first floor in north wall.

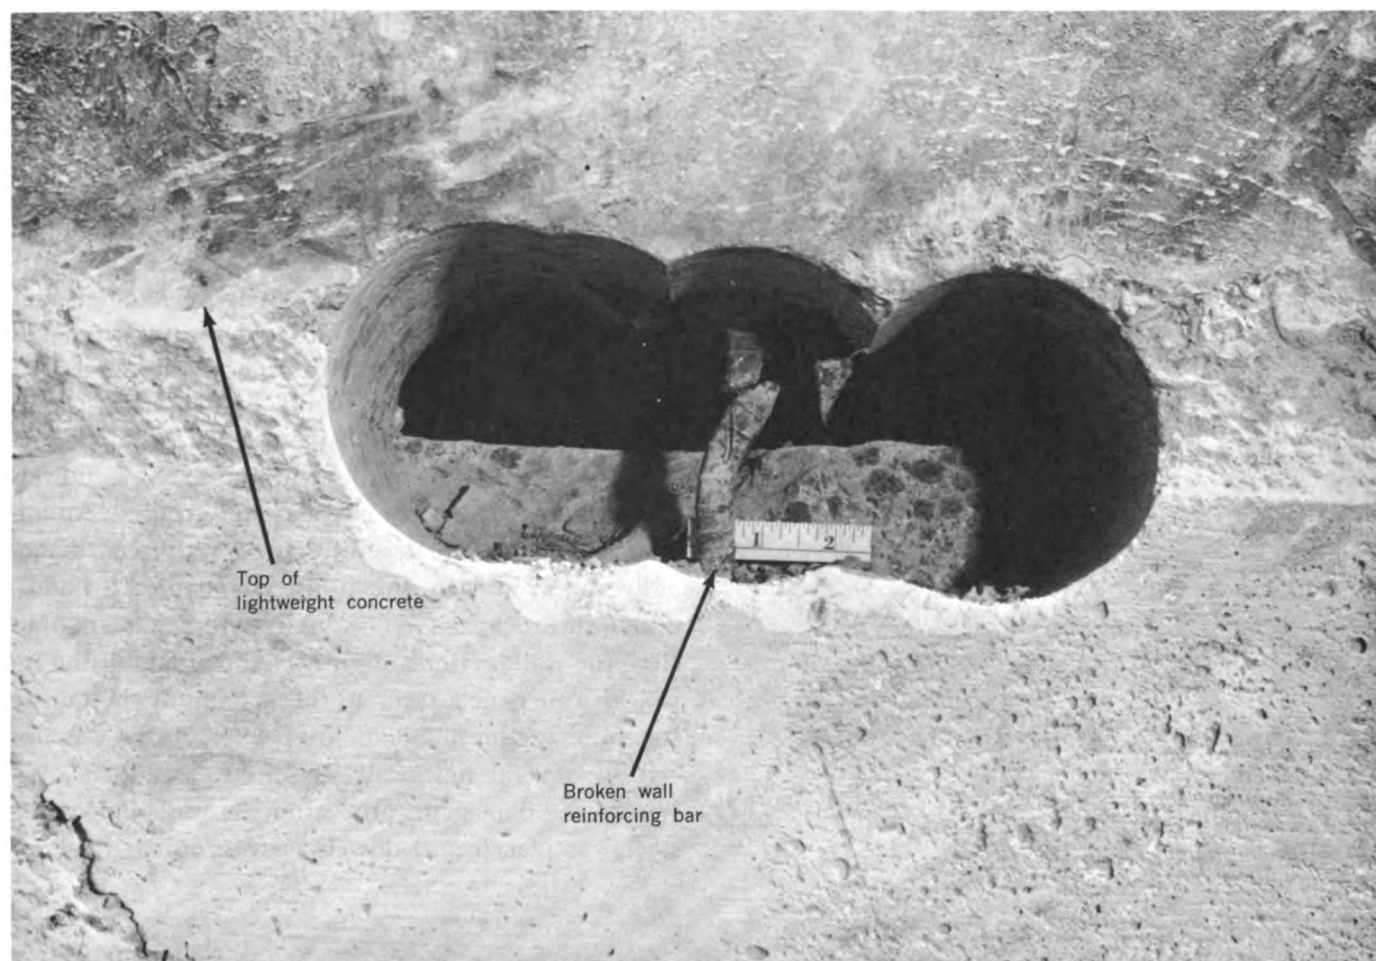
Figure 9.—Museum for Antique Cars. Typical wall reinforcing bars at first floor in north wall. Note offset of upper portion of bar to right of lower portion.

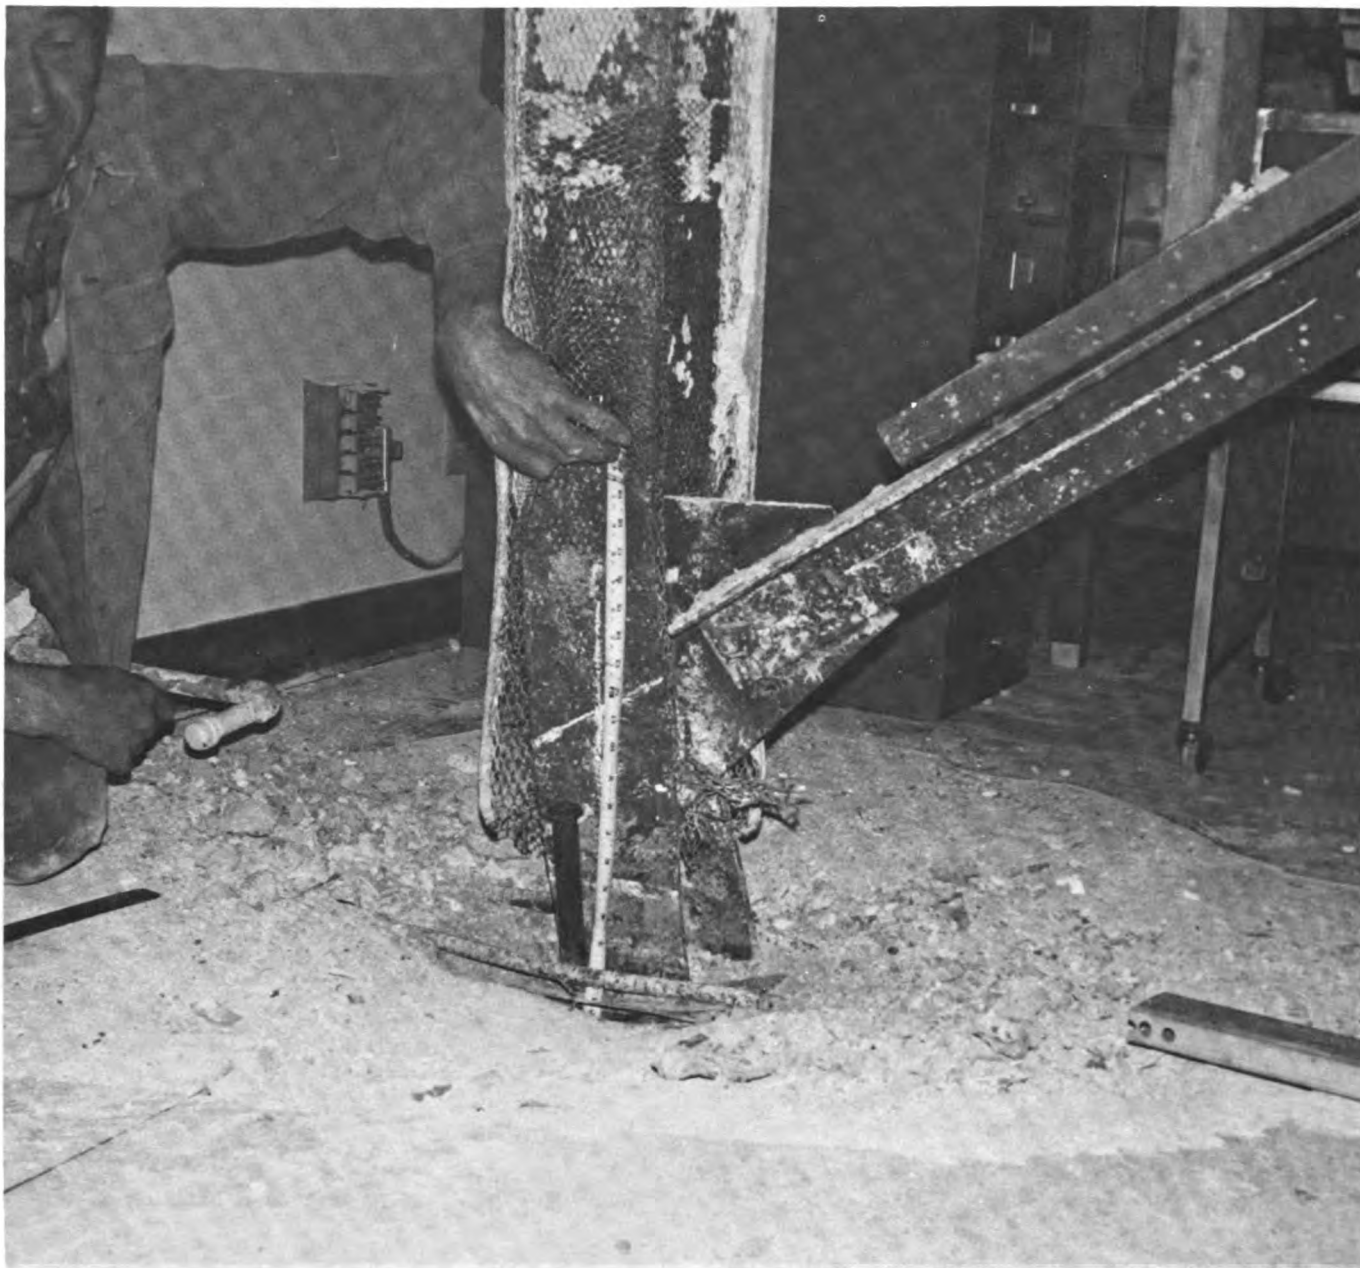
Figure 5.—Foothill Medical Center. Base of 5WF16 column on line 3 with diagonal brace connection. Note eccentricity of brace of  $11\frac{1}{2}$  inches. E. E. Schader photograph.

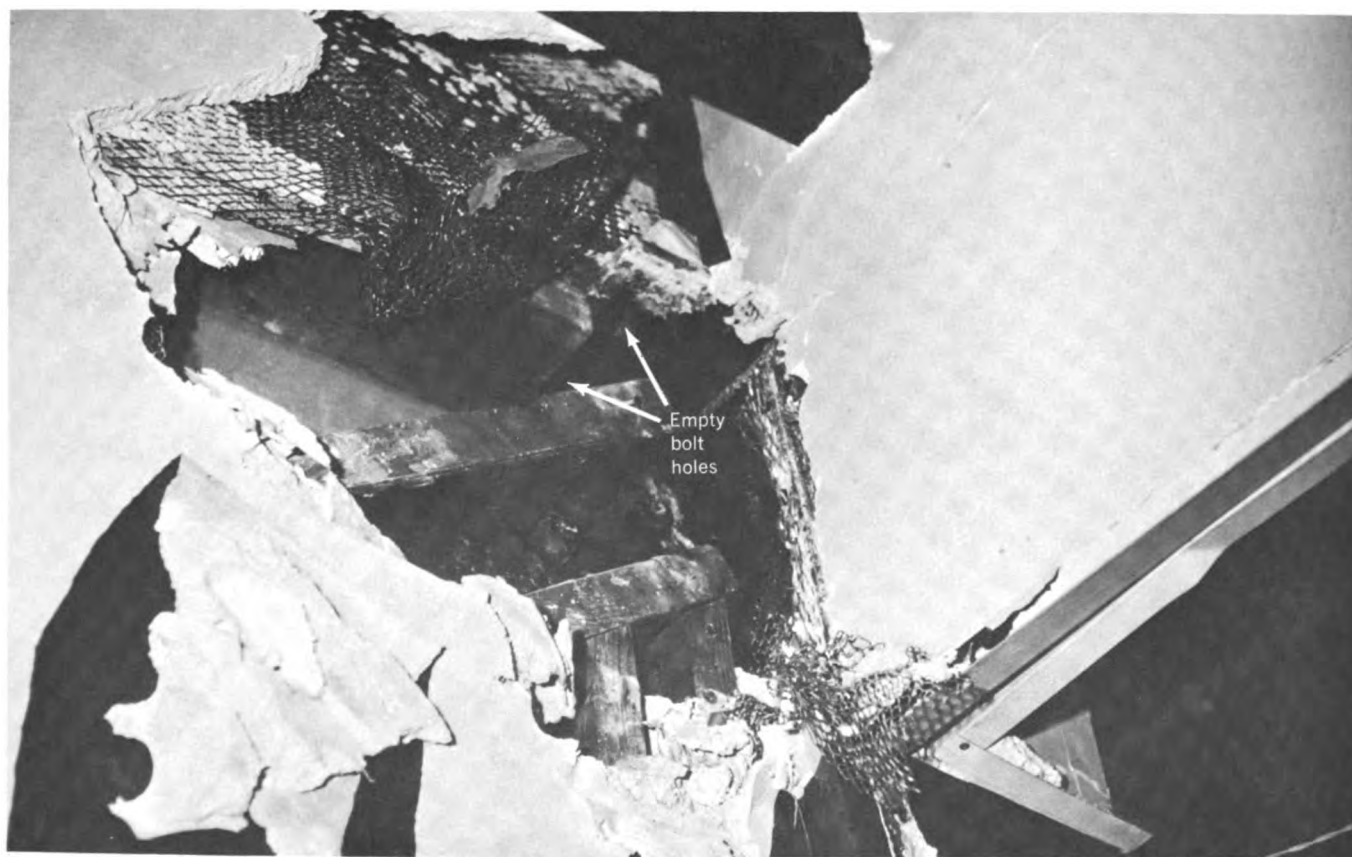
*Figure 8.—Foothill Medical Center. Connection underneath second floor on line 3 at line C. Note empty bolt holes to bottom flange of beam. Loring A. Wyllie, Jr. photograph.*

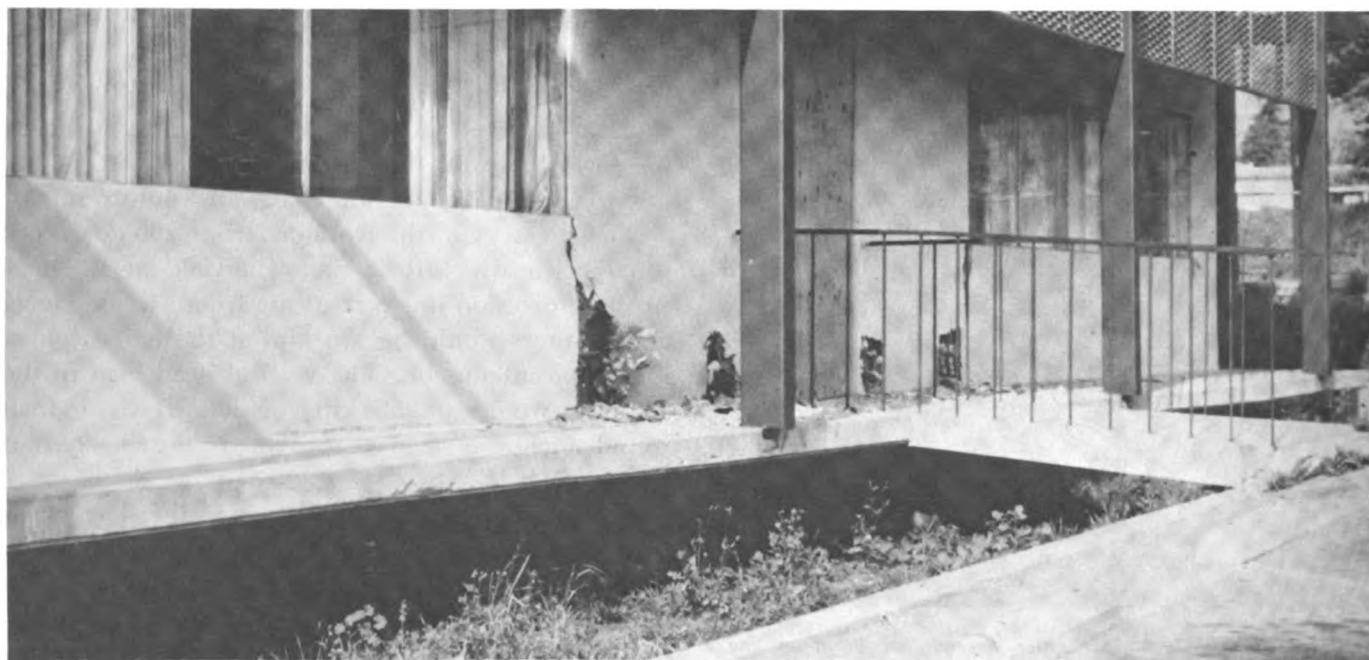
*Figure 9.—Foothill Medical Center. Rear or south end of building, showing plaster damage at base of columns on line 11 at bracing. Loring A. Wyllie, Jr. photograph.*

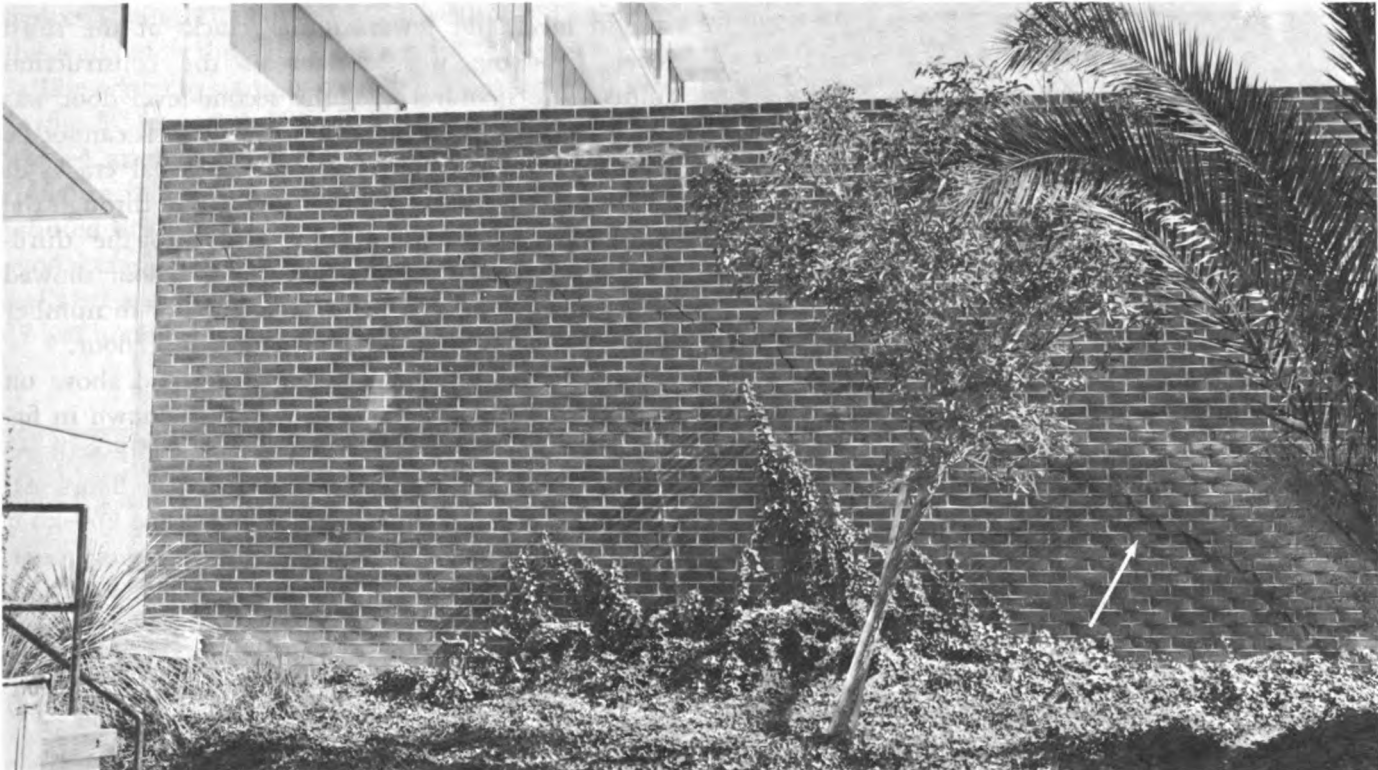
Figure 9.—Pacoima Memorial Lutheran Hospital. Grouted brick wall at west end of cafeteria-mechanical unit. Note diagonal crack shown by arrow. Paul Fratessa photograph.

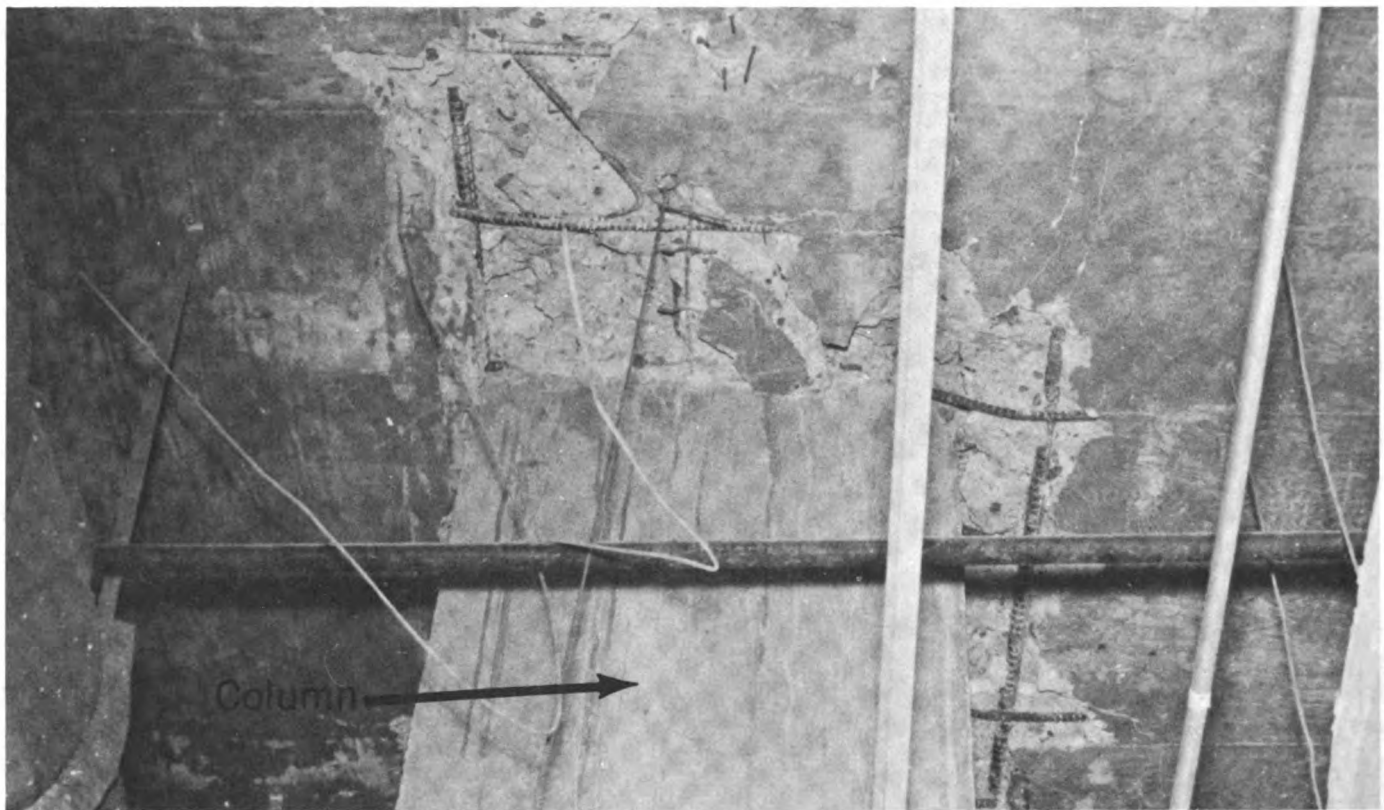
*Figure 22.—Olive View Hospital, medical treatment and care unit. Spalling of concrete slab under second-floor framing caused by rotation through connection.*

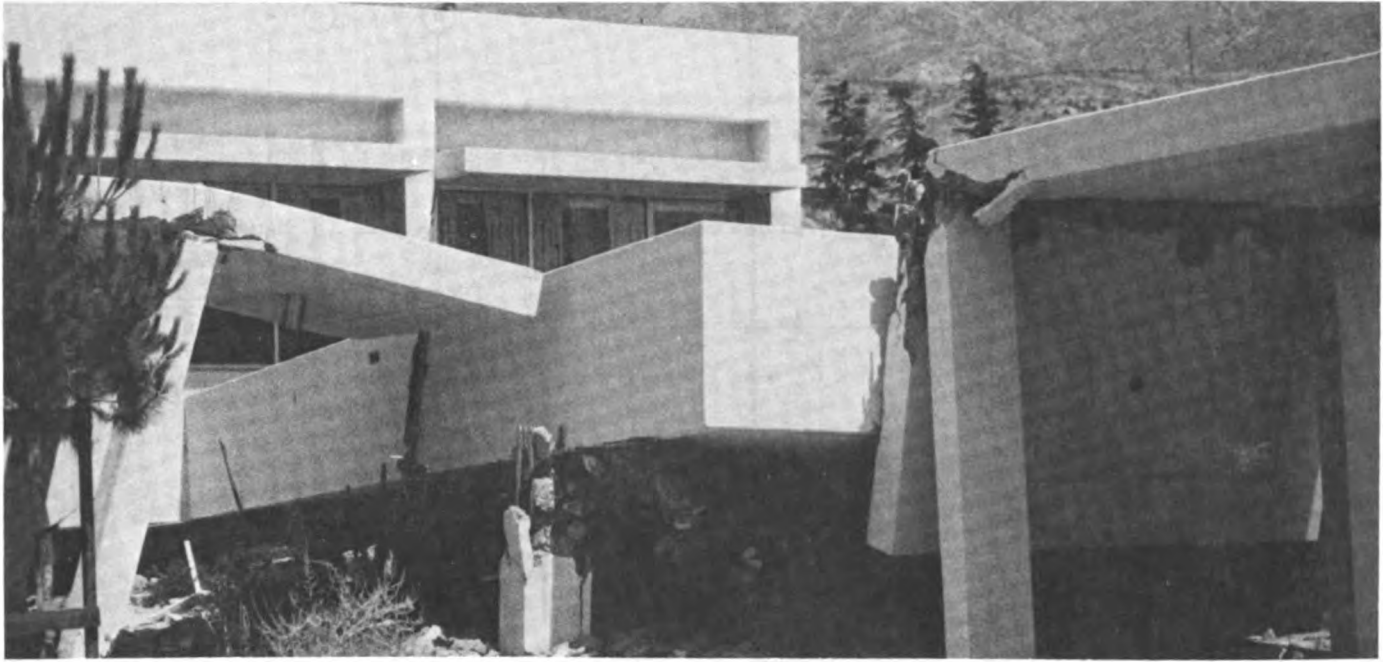
Figure 65.—Olive View Hospital, walkway canopy. Collapse of cantilevered roof, resulting from collapse of psychiatric unit.
